UNIFIED SEWERAGE AGENCY
SURFACE WATER MANAGEMENT
SUBBASIN STRATEGIES

Hedges Creek Subbasin

DECEMBER 1995

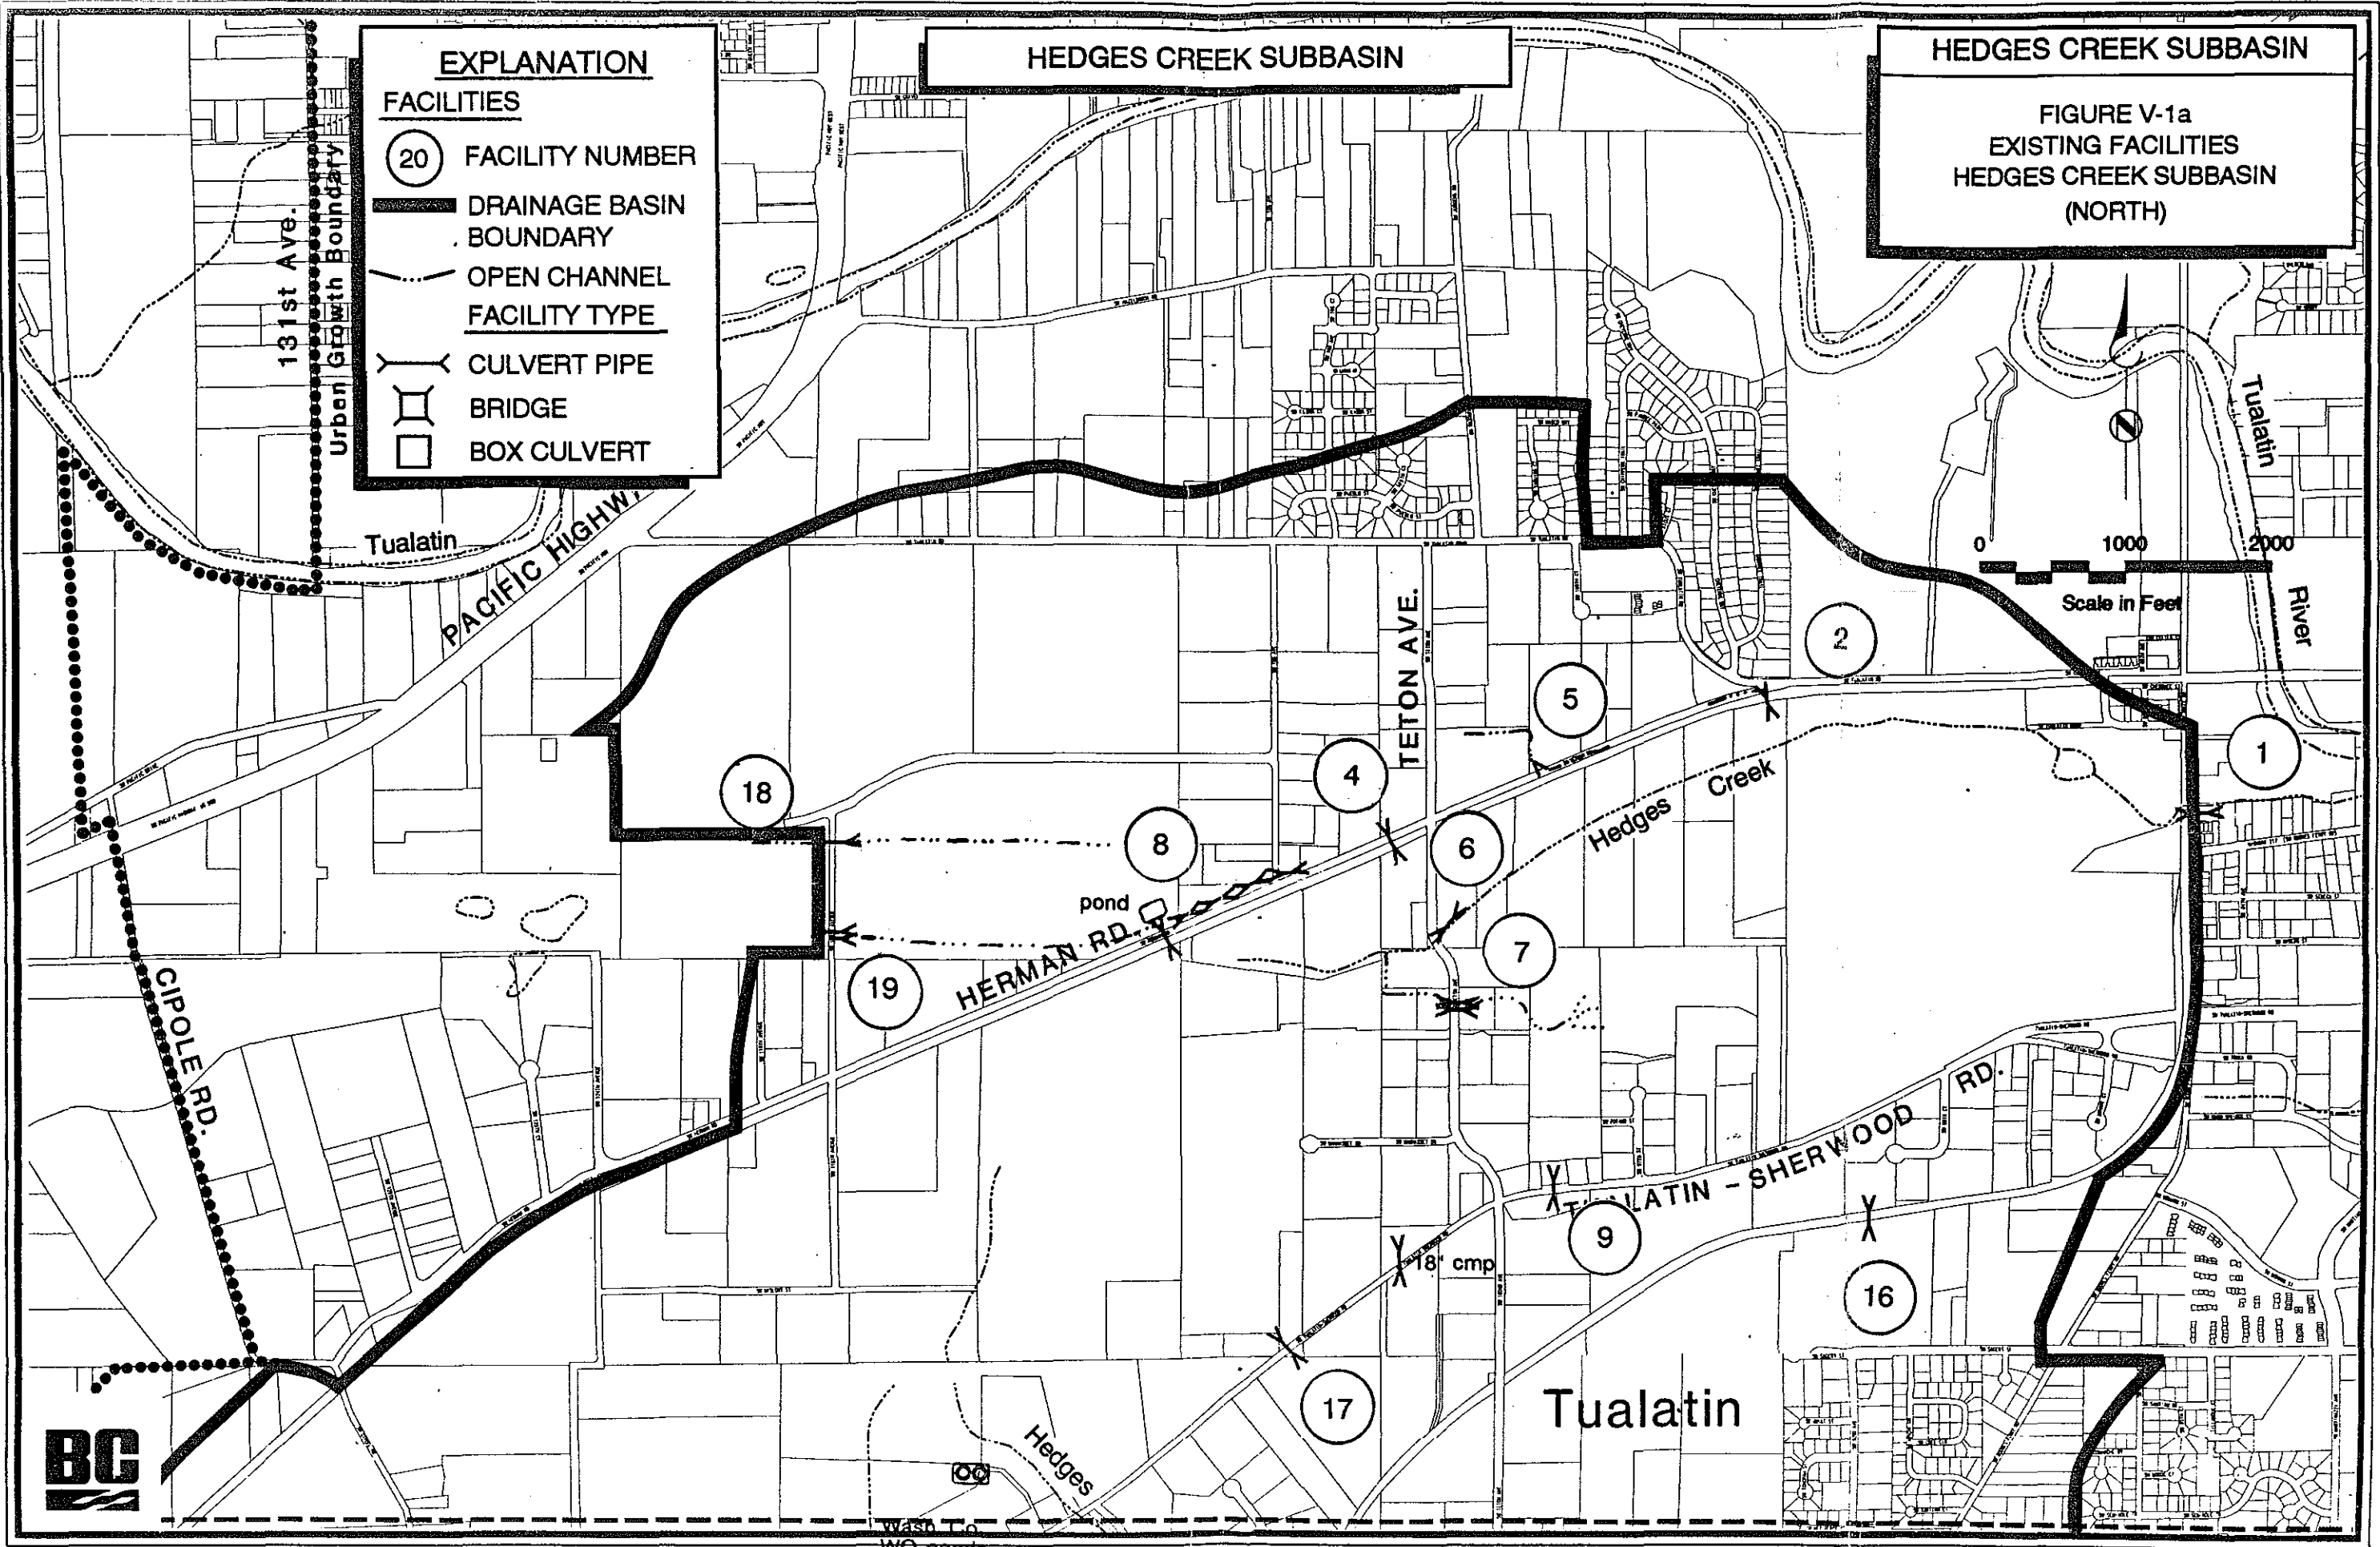
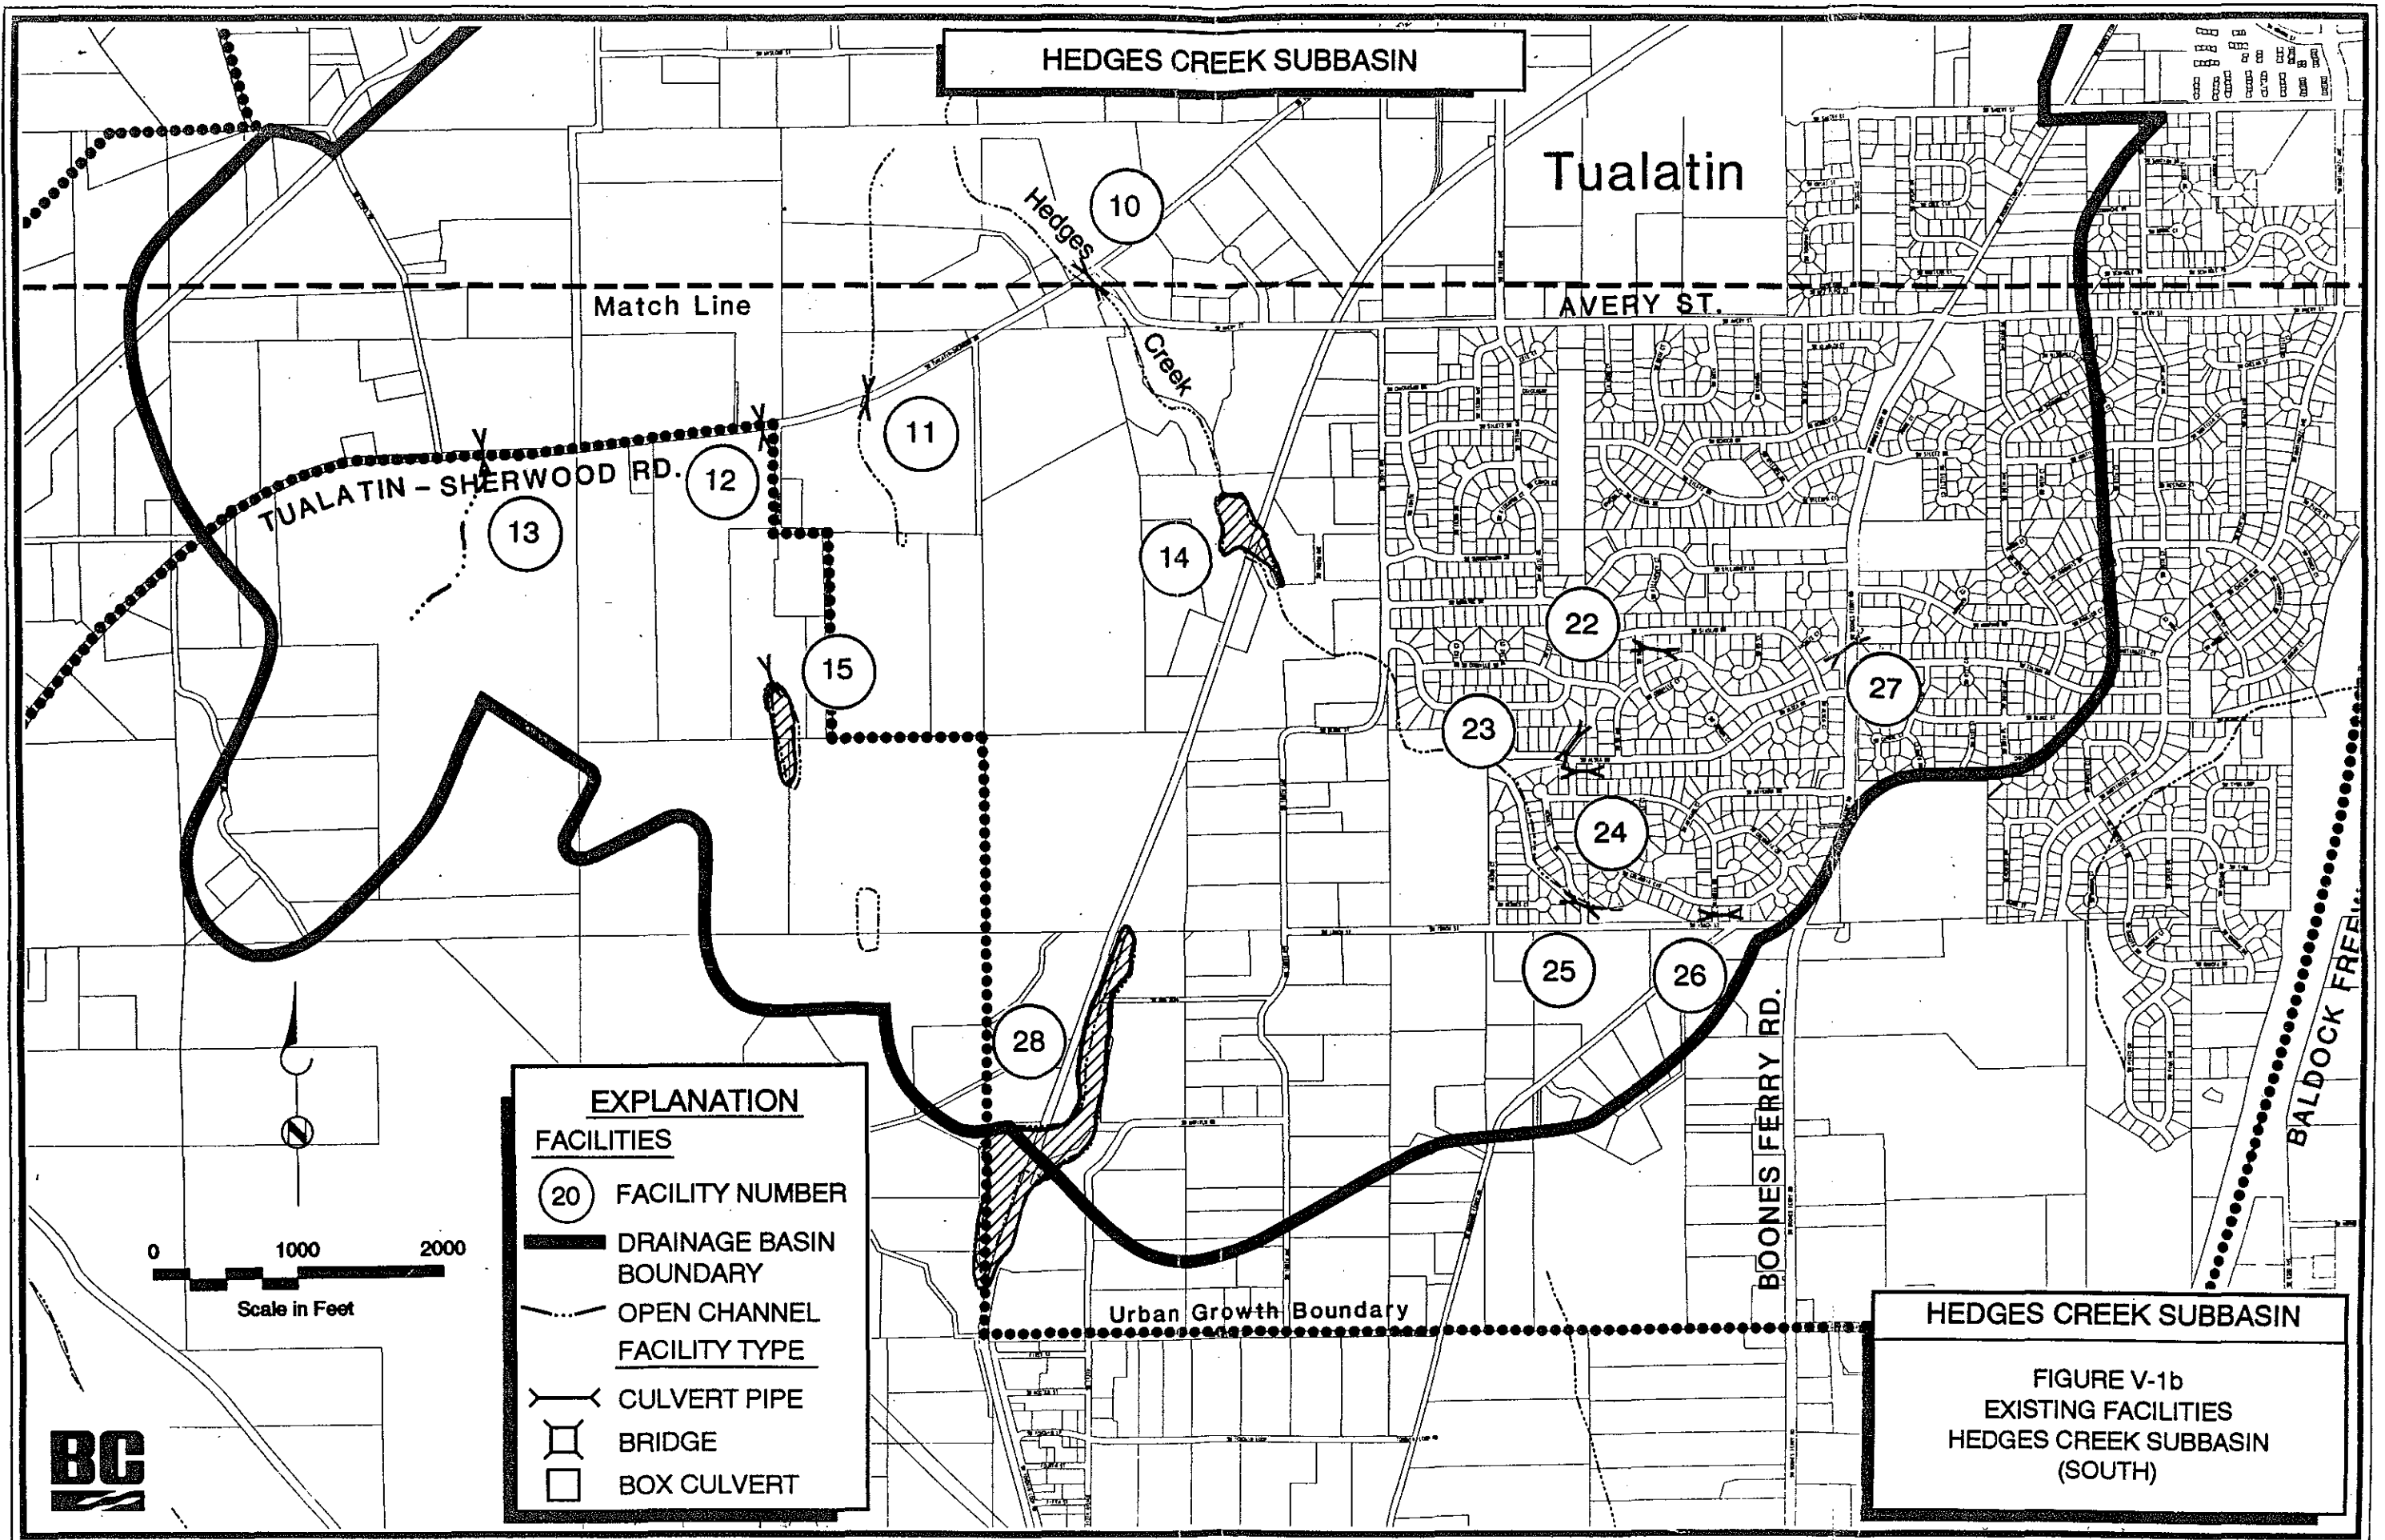
Map overlays for soil erosion categories are shown in Figures 1a-1d. For both Hedges and Butternut Creeks, there is greater erosion hazard in the southern portions of the drainage basins. In both locales the increased erosion hazard is due in part to the steep slopes. In the Butternut area, the soils in the southern section also have fragipans, which increase the erosion potential.

The northern areas of Hedges and Butternut Creek drainages consists of level to gently sloping topography. The soil erosion hazard is generally low in these areas. There is a category 5 area in northern Hedges Creek basin. This is a steep (12 to 20% slopes) area of Hillsboro loam soil. In the Butternut drainage, there are several areas of category 4 erosion potential in the northern section. These areas flow Butternut Creek and its tributaries.
